# Implant News & Views

November/December 2002

## Rescuing Bridges in Trouble

by Dr. N. Shreve Spitler

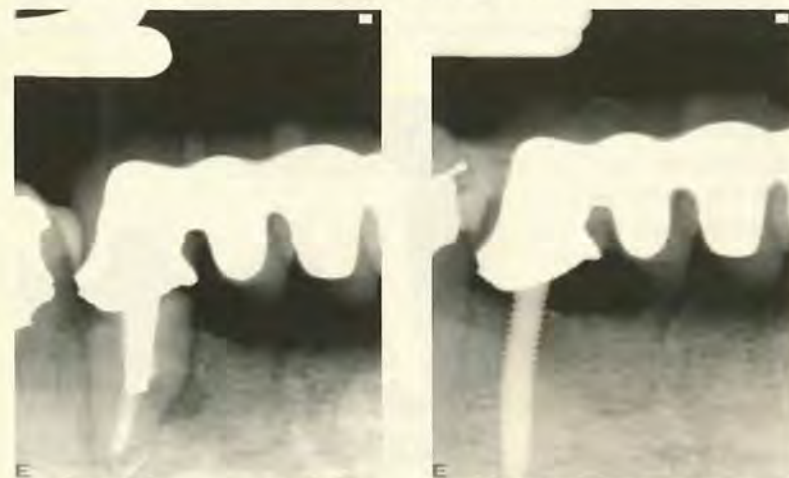
fig. 6 - The 86 year-old male patient presented with a mandibular fixed bridge canine to canine. In 1999 one abutment, tooth #27, became painful to pressure due to a vertical split in its non-vital root. The bridge was removed without damage. Tooth #27 was extracted. The bridge was recemented to tooth #22 and splinted with a horizontal titanium bar bonded with a composite.

fig. 6a - After 6 months of healing, a Dentatus implant was placed in the area of #27. The bridge was adapted with Unifast, resplinted and recemented. It is fully functional after 3 years.

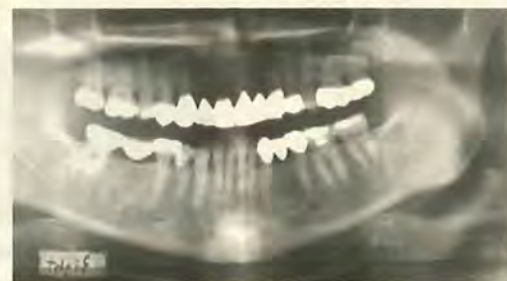
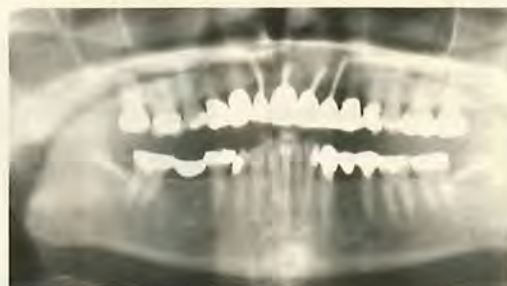
fig. 7 - This 59 year-old woman first presented in January 1985 to recement her upper anterior 8-unit bridge. Prognosis was poor, due to few abutment teeth and unfavorable leverage.

fig. 7a - In November 1985, the bridge loosened and required recementing once a year. In May 1998 four Dentatus implants were inserted and the four bridge pontics were retrofitted to them. The bridge has remained solidly in place for 4 1/2 years.

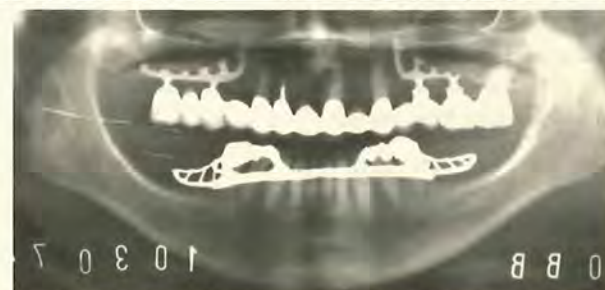
fig. 8 - This dentition was rescued 3 times over 27 years, utilizing 3 varieties of implants. In 1973, bilateral maxillary blade implants were inserted to replace an uncomfortable partial denture. All functioned well for 17 years.

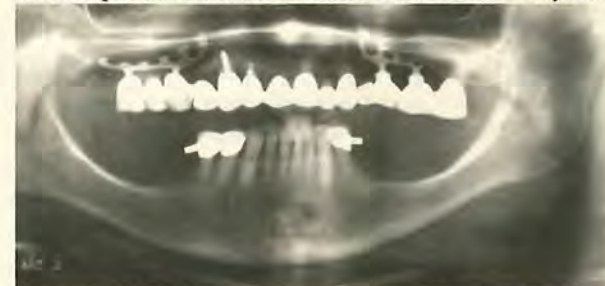
fig. 8a - May 1990 panorex reveals bone resorption at right implant. Ceka anchors supporting lower partial denture are visible on lower premolars.

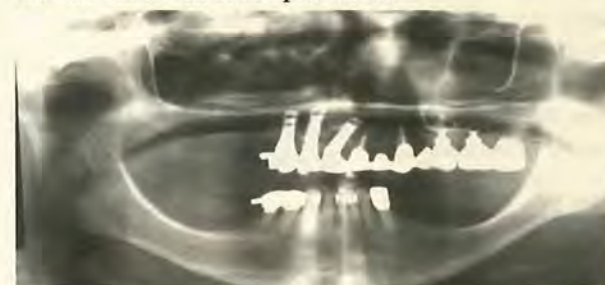
fig. 8b - In January 1992, the right blade was removed. Teeth #'s 6-7 were mobile. The patient rejected a sinus lift for new posterior implants. So, HA coated Biovent implants were placed at #'s 6,7,8 location. After integration 3 splinted crowns were attached with a Dalbo cast into # 6 crown. A unilateral partial denture was fabricated, which still functions well today.

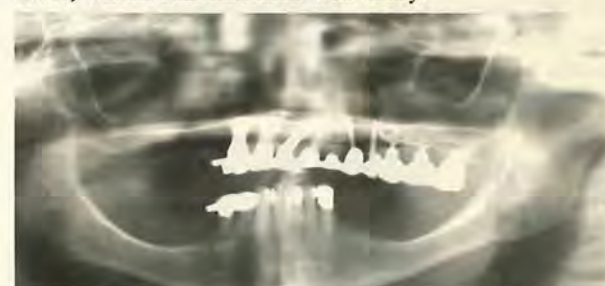
fig. 8c - In October 1998 patient presented with a vertical root fracture of #11 and it was removed. Crowns #'s 8-9 were splinted to reduce the overload while #11 socket healed. In November 1999 two Dentatus implants were placed in areas 11 and 12 for additional support. The bridge was adapted to fit over the implants and recemented. This 86 year-old woman is comfortable and functioning well with the left blade implant for over 29 years.

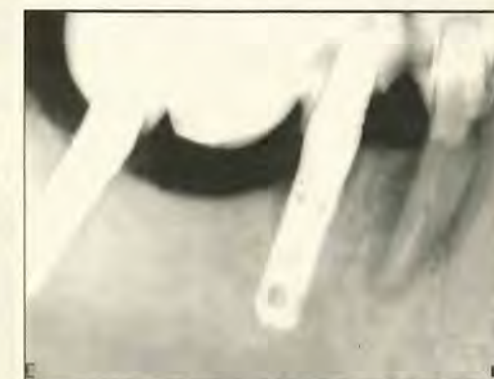
fig. 1 - An 83 year-old male presented with bridge abutment tooth #28 infected and painful due to a split root. It was extracted in March 2000.

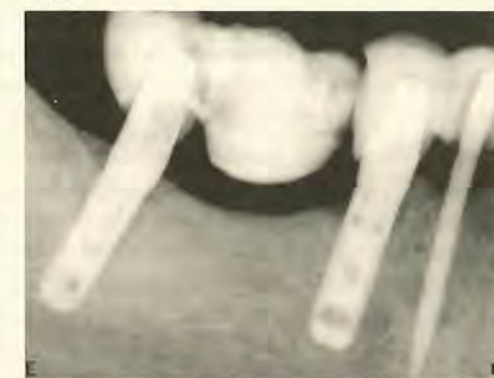
fig. 1a - Six months later, one Dentatus MTI implant was placed. The pontic was remade and bonded to the bridge.

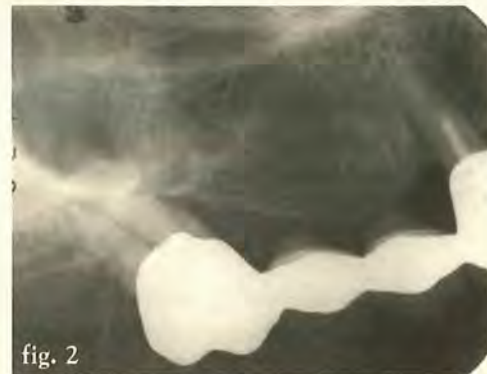
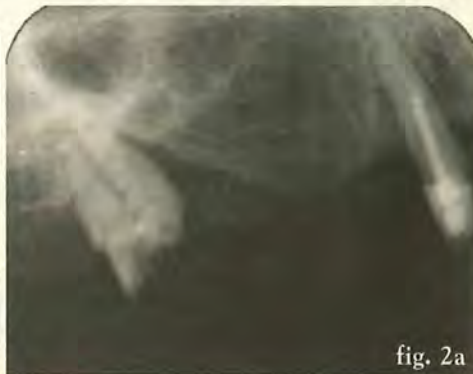
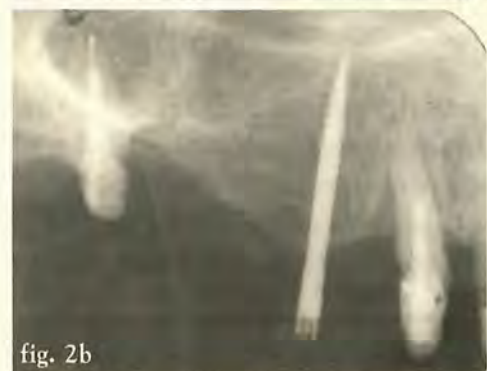
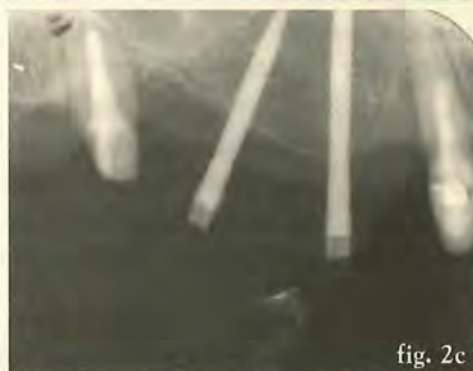
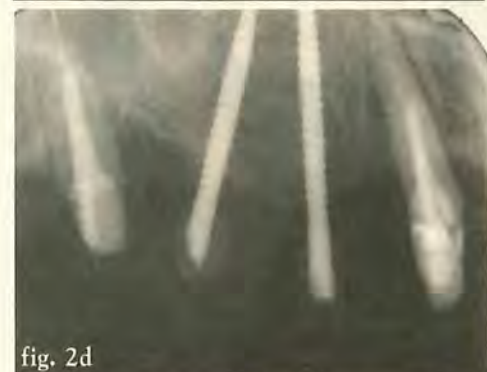
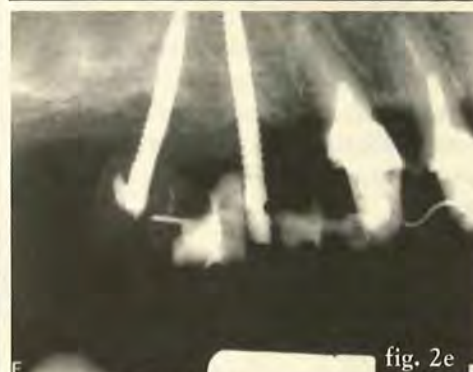
**fig. 2 -** The 86 year-old female patient developed severe periodontal disease at the molar bridge abutment. In 1995 two Dentatus MTI implants were placed into the premolar region to support a reinforced composite bridge. The molar remained in place for several months, became symptomatic and was extracted. A wire reinforced composite bridge was placed. The bridge is tight and functioning well for over seven years.

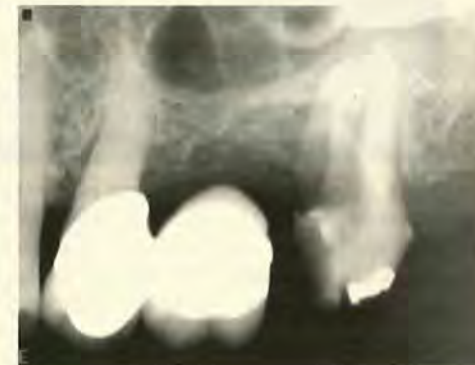
**fig. 5 -** This 83 year-old female presented in November 2001 with severe root caries in tooth #15. The abutment crown

was cut away from the pontic and tooth #15 was extracted.

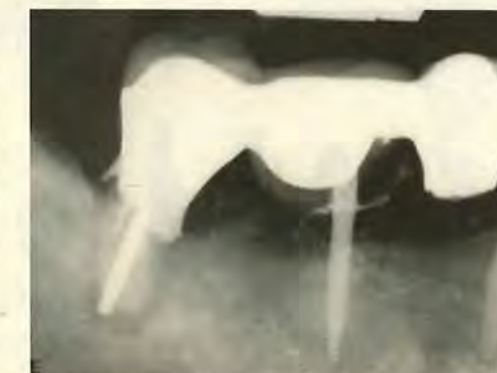
**fig. 3 -** The bridge abutment tooth #29 was lost due to periodontal disease. An Imtec MDI implant was placed into #30 pontic. Teeth #'s 27 and 28 were splinted.

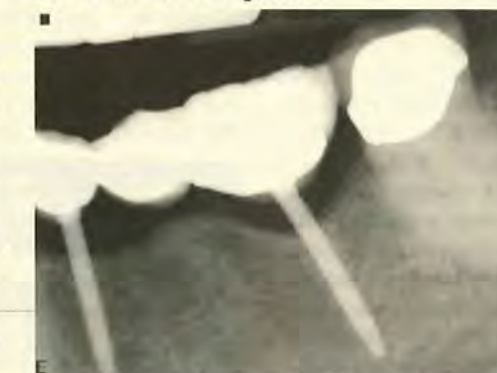
**fig. 4a -** Another MTI Implant at #21 area was added the following year.

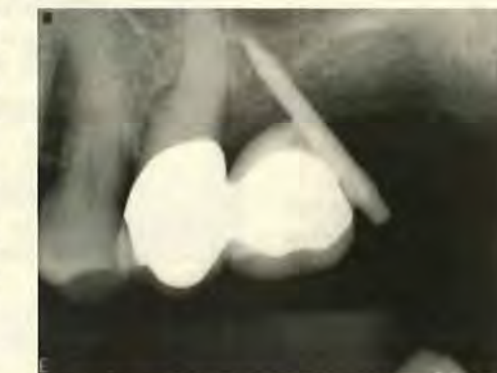
**fig. 5a -** In December 2001, the pontic was grooved at the distal portion to allow placement of a diagonal Dentatus implant. The implant was bonded to the pontic with Geristore oval cure composite. For additional support, teeth #12 & 13 were splinted by cutting an occlusal groove into which Ribbond was placed with a flowable light cure composite. As of August 2002, the patient was comfortable and functioning well.
